The Heathkit HW-101 by Greg Latta, AA8V

HP-23/PS-23 Power Supply Restoration

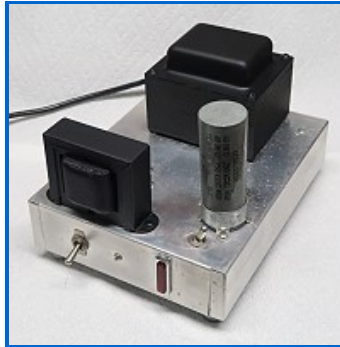
Fully Restored Power Supply - March 27, 2022

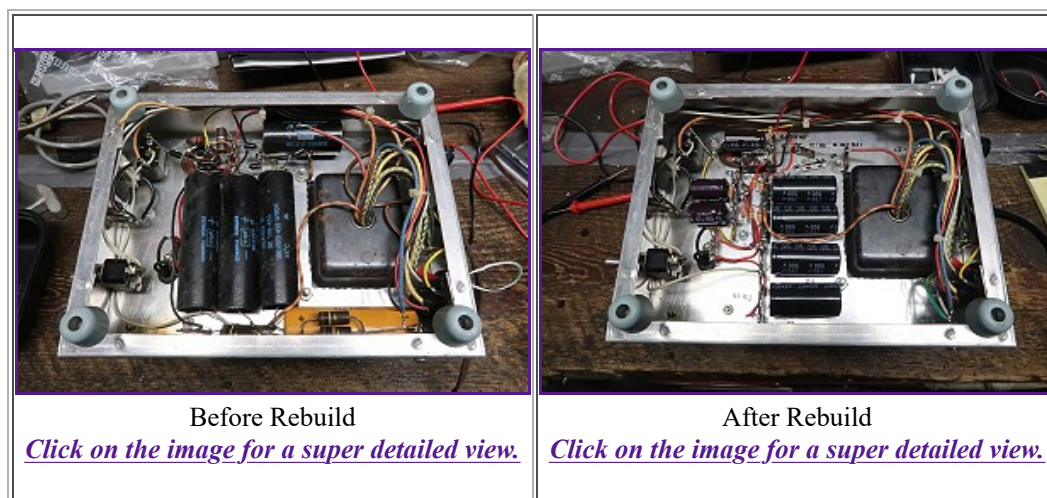
The left picture below shows the original parts and wiring. The right picture shows the new parts and wiring.

The original parts were mounted on terminal strips, and I used the same mounting method when installing the new parts. I had to change things around since the new capacitors had radial leads rather than axial leads and were much smaller than the original capacitors. I have a big collection of terminal strips and was able to come up with an efficient arrangement. This required carefully drilling several new holes in the chassis to mount the new terminal strips.

At left center is a vertical 4-terminal strip with two purple electrolytic capacitors that carries the bias supply components. The purple capacitors are C6 (47uF/160V) and C7 (47uF/160V). Resistors R7 (1kohm) and R8 (27kohm) are also mounted on this terminal strip. Diode D7 (1N4007) runs from the voltage select switch at top left to the top of this terminal strip.

B+ circuit components are mounted on a 6-terminal strip (bottom center), two 3-terminal strips (top center), and a 2-terminal strip at left bottom. The bottom vertical 6-terminal strip holds C4 (150uF/500V, bottom) and C3 (150uF/500V, 2nd from bottom). At top, mounted on a vertical 3-terminal strip is purple capacitor C5 (47uf/450V). Resistor R5 (100kohm) is also mounted on this terminal strip. Immediately below C5 at top is a horizontal 3-terminal strip that carries diodes D5 (1N4007) and D6 (1N4007). At bottom left a vertical 2-terminal strip holds the black leads from the filter choke.

Diodes D1-D4 (1N4007) can be seen at top center mounted on several small terminal strips. Capacitors C1 (150uF/500V, top) and C2 (150uF/500V, 2nd from top) can be seen mounted on a vertical 6-terminal strip at center. Bleeder resistors R1-R4 (100kohm) are also mounted on this terminal strip.

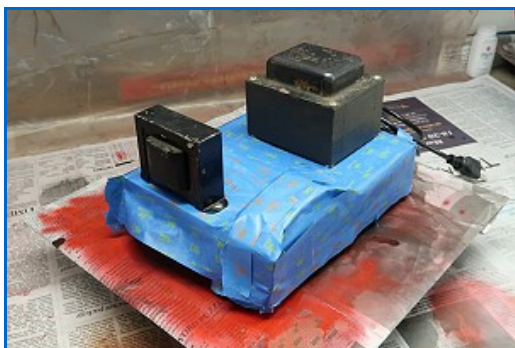
Though the power supply was in pretty good shape, the transformer and choke were rusted and I decided to airbrush them. This

First the choke and transformer are cleaned and the chassis is masked off.

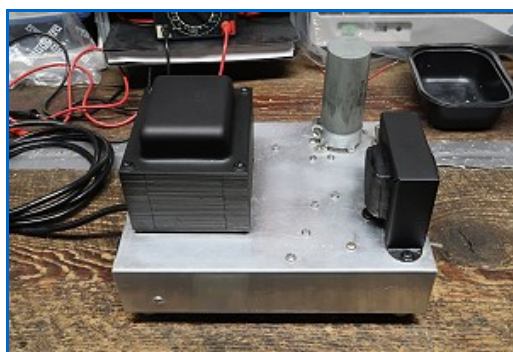
After airbrushing the power supply looks brand new!

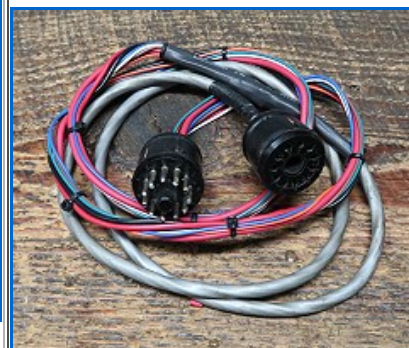
The Finished Cord
