YO4HFU

KENWOOD TK-880

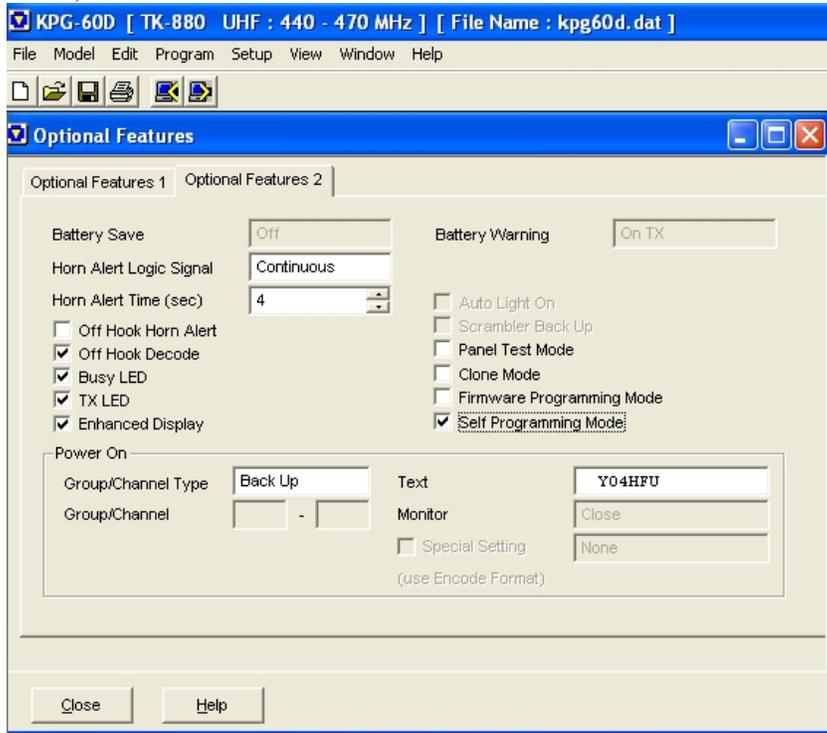
Radio display when internal CPU is accessed by computer:

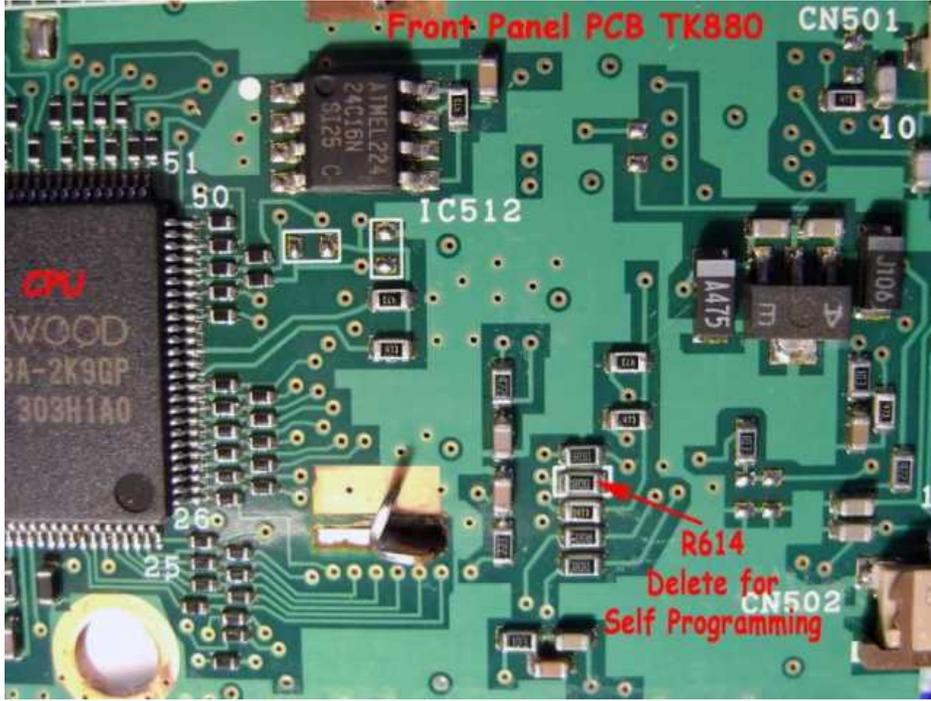
In order to activate the feature, R614 "zero ohm" resistor must to be deleted! This resistor is located on front panel PCB, near to CPU.

After that, the radio channels can be programmed directly by front panel keys.

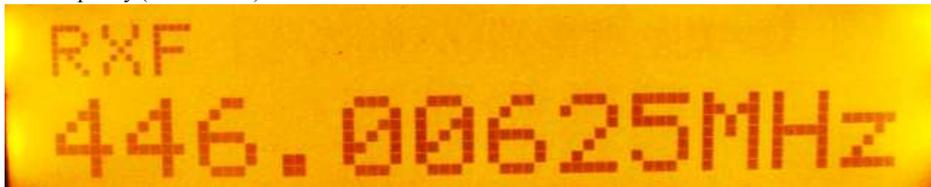
RX Frequency (PMR CH-1)

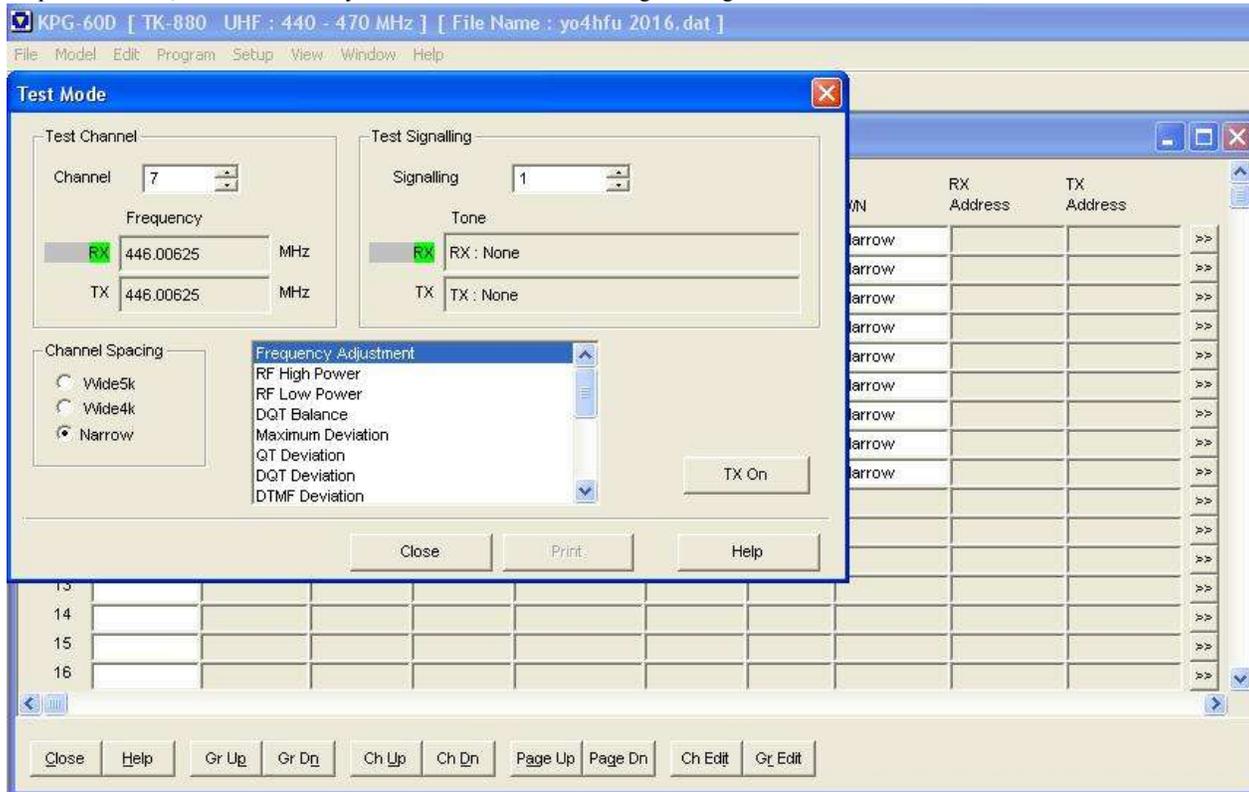
- Open KPD-60D, TEST Menu is easy to use. Connect data cable and go to Program / Test Mode.

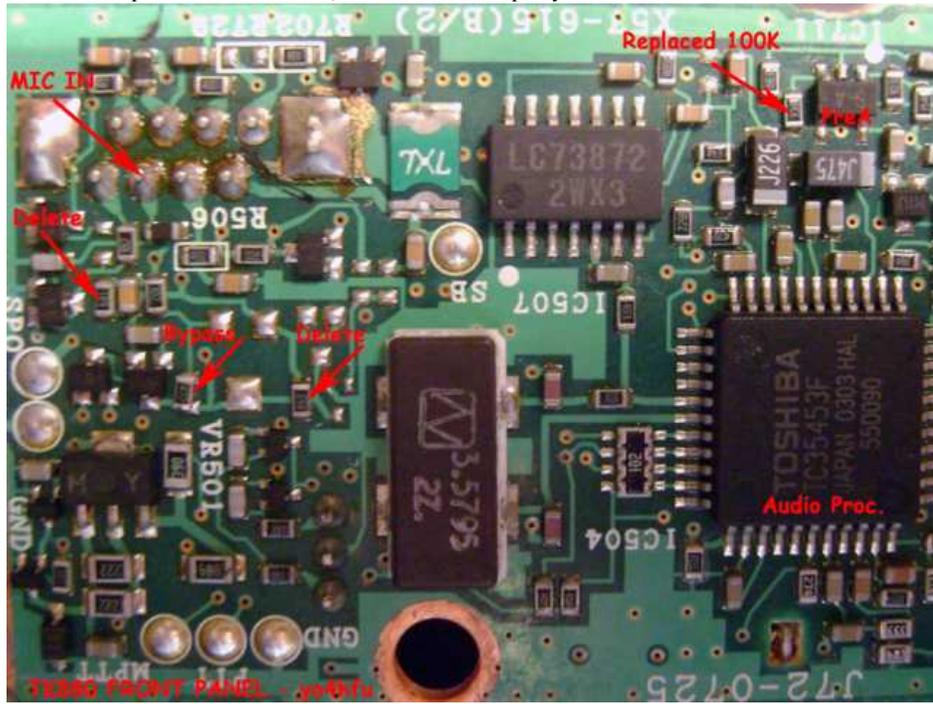
During testing I noticed a low signal to noise ratio for TX. Background noise was higher than my GP300 monitor. After investigation, IC711 microphone preamplifier was found with poor performances. IC preamplifier is located on Front Panel PCB.

Next try was to decrease the gain. Feedback R721(330K) resistors was replaced by 100K. Good results but *level of modulation* was affected. Immediately i saw some resistors between microphone connector and preamplifier stage. Why to decrease the microphone level using resistors and after again to boost the signal? The S/N ratio will be forever degraded...

All dividers were removed in order to increase the original level of modulation: R512(680) removed; R724(4K7) bypassed; R725(15K) removed (resistors values found in my radio, not same with Service Manual. Please check SM diagram).

Final result: improved TX modulation, close to Motorola quality...hi.
